# Personal electronic device fire in-flight involving Boeing 747, VH-OJS

500 km WNW of John F. Kennedy International Airport, United States, 21 June  
2016

**ATSB Transport Safety Report**  
Aviation Occurrence Investigation  
AO-2016-066  
Final – 28 September 2016

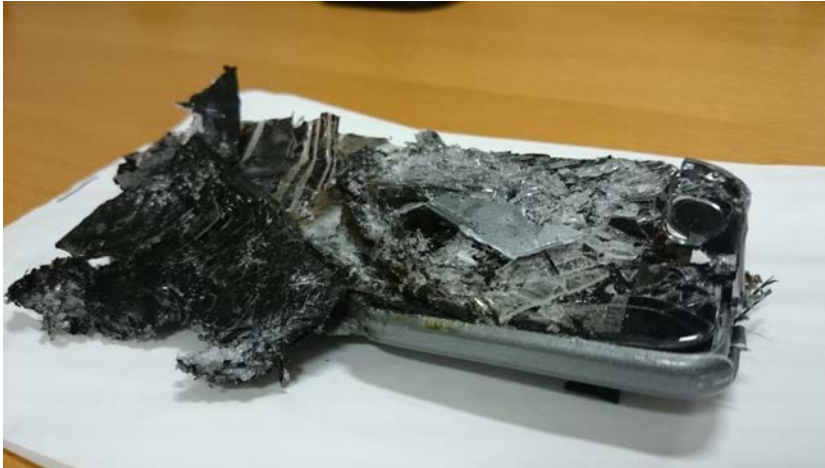
After confirming the PED fire had been extinguished, the cabin crew attempted to remove the PED in order to place the device in water, in accordance with lithium type battery fire procedures. The PED could not be removed without further damage and risk of fire. Therefore, the cabin crew elected to leave the device in place and position a crewmember with a fire extinguisher near seat 3A for the remainder of the flight. About 10–15 minutes after the incident, this crewmember identified further heat coming from the crushed PED. They again discharged the fire extinguisher onto the PED, eliminating the heat.

**Figure 1: Crushed PED after removal from seat**

- A review of reported events revealed 22 similar occurrences of trapped or crushed PEDs. Seven of these occurrences resulted in smoke and/or heat being produced. This incident was the first event to result in fire.
- The investigation determined that the likely area for the PED to intrude into the seat mechanism was adjacent to the seat belt anchor point. This area becomes more exposed as the seat reclines towards the flat position.
- Mesh netting within the seat structure is designed to capture objects that fall behind the seat. Damage to seat 3A consisted of an approximate 5 cm melt area to this mesh netting. There was no other damage noted to the seat structure.

As a result of this occurrence, the aircraft operator has advised the ATSB that the seat manufacturer is developing design solutions to prevent ingress of PEDs into the seat structure.

If you lose your electronic devices at any time, it's important you don't move your seat as this could severely damage your device and may be a fire hazard. Please contact a crew member who will be able to recover your device.
